Petrographic Investigation of A Concrete Core Extracted from the Backwall of the US 89 Bridge Over Belt Creek

David Rothstein, Ph.D., P.G., FACI
Report No. 217649.d
2 June 2021

US 89 Over Belt Creek Backwall Core Petrography

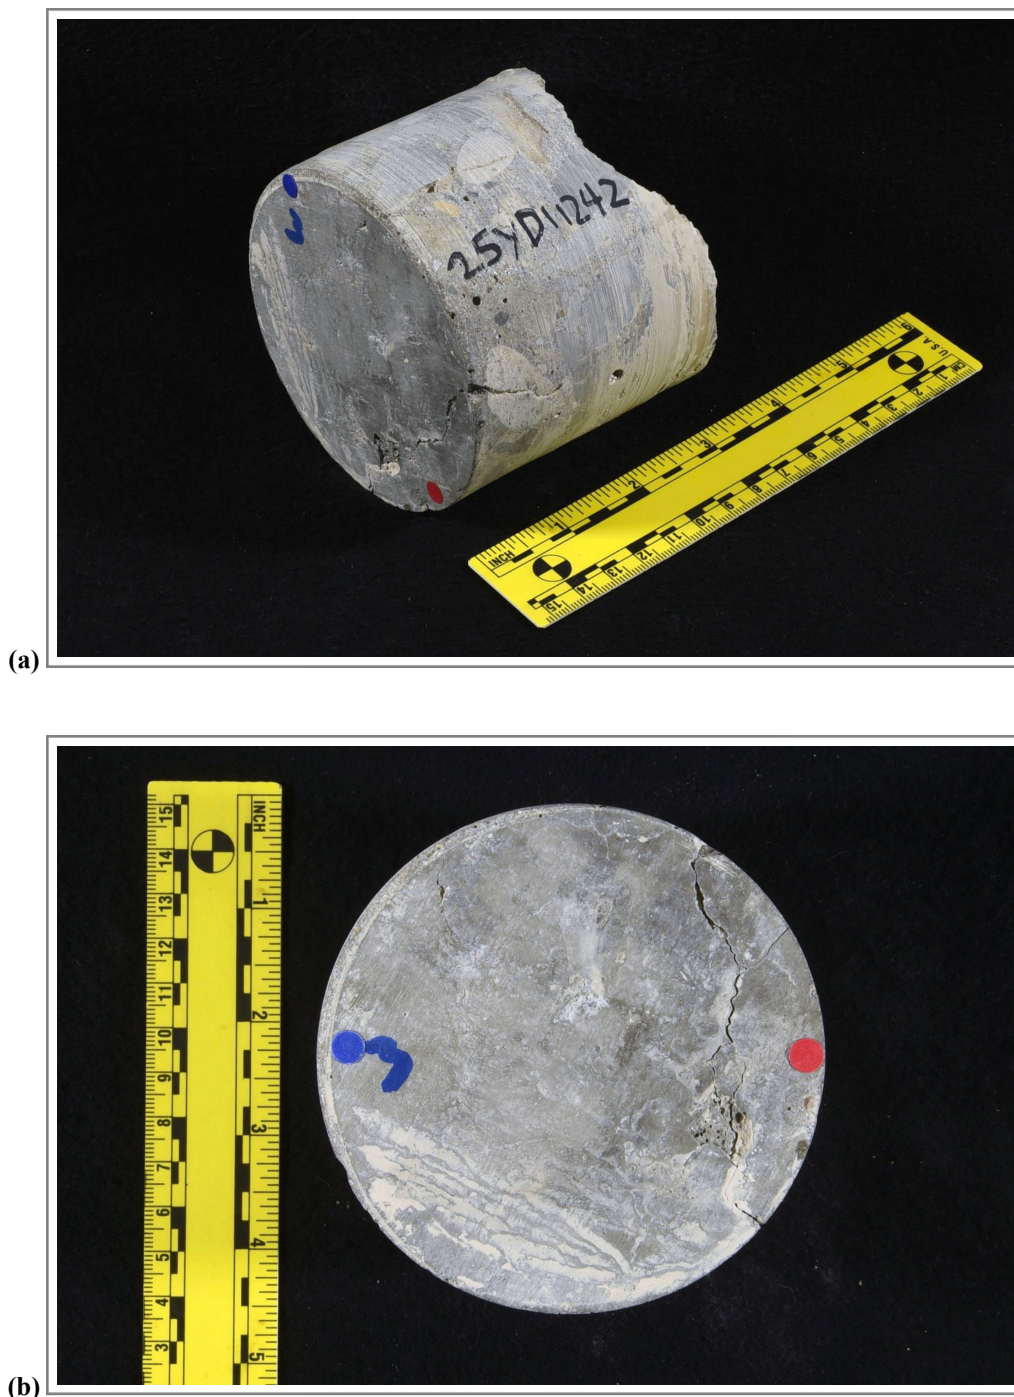
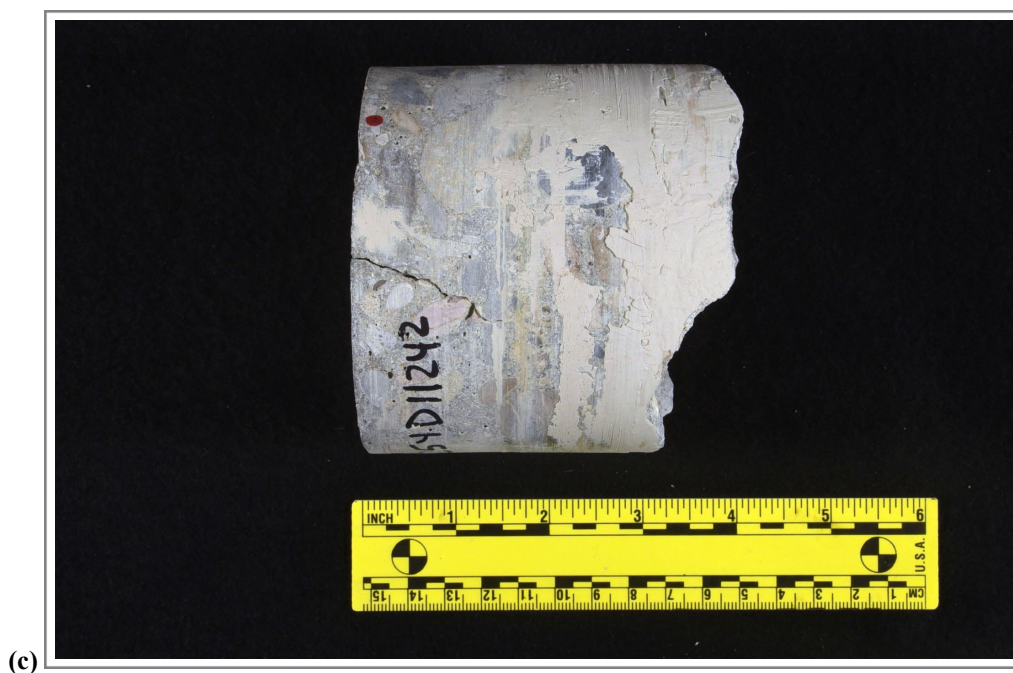
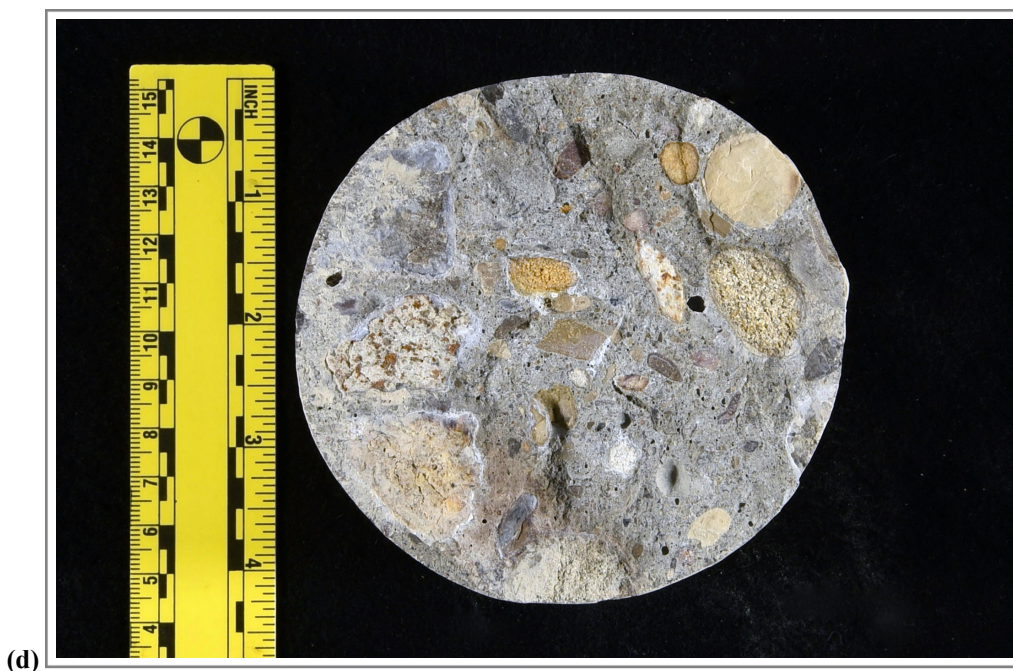
Figure A1. Photographs of the core in as-received condition showing (a) an oblique view of the outer surface and side of the core with identification labels and (b) the outer surface of the core. The red and blue dots show the orientation of the saw cuts used to prepare the core. The small and large divisions are in centimeters and inches, respectively.

Figure A1 (cont'd). Photographs of the core in as-received condition showing (c) the side of the core and (d) the inner surface of the core. The small and large divisions are in centimeters and inches, respectively.

- The core is horizontal in orientation and measures ~ 95 mm (3 ¾ in.) in diameter (**Figure A1, Figure A2**). The outer surface is formed and the inner surface is a fracture, such that the core represents a partial thickness of the backwall (**Figure A3**). White secondary deposits consisting of ASR gel were observed on the inner fracture surface (**Figure A4**).

1. RECEIVED CONDITION	
ORIENTATION & DIMENSIONS	Horizontal core from bridge backwall measures ~ 95 mm (3 ¾ in.) in diameter and 65-85 mm (2 ½-3 ⅜ in.) in length (Figure A1, Figure A2).
SURFACES	The outer surface is formed and the inner surface is a fracture such that the core represents a partial thickness of the backwall (Figure A3). The inner surface cuts through aggregate particles; white secondary deposits observed commonly rimming aggregate particles (Figure A4).
GENERAL CONDITION	The core is hard and compact. Several cracks observed on outer surface that range from hairline (~ 100 µm or 4 mil wide) to 250 µm (10 mil) wide. The cracks are mostly linear with several triple points observed. White secondary deposits observed on outer surface.

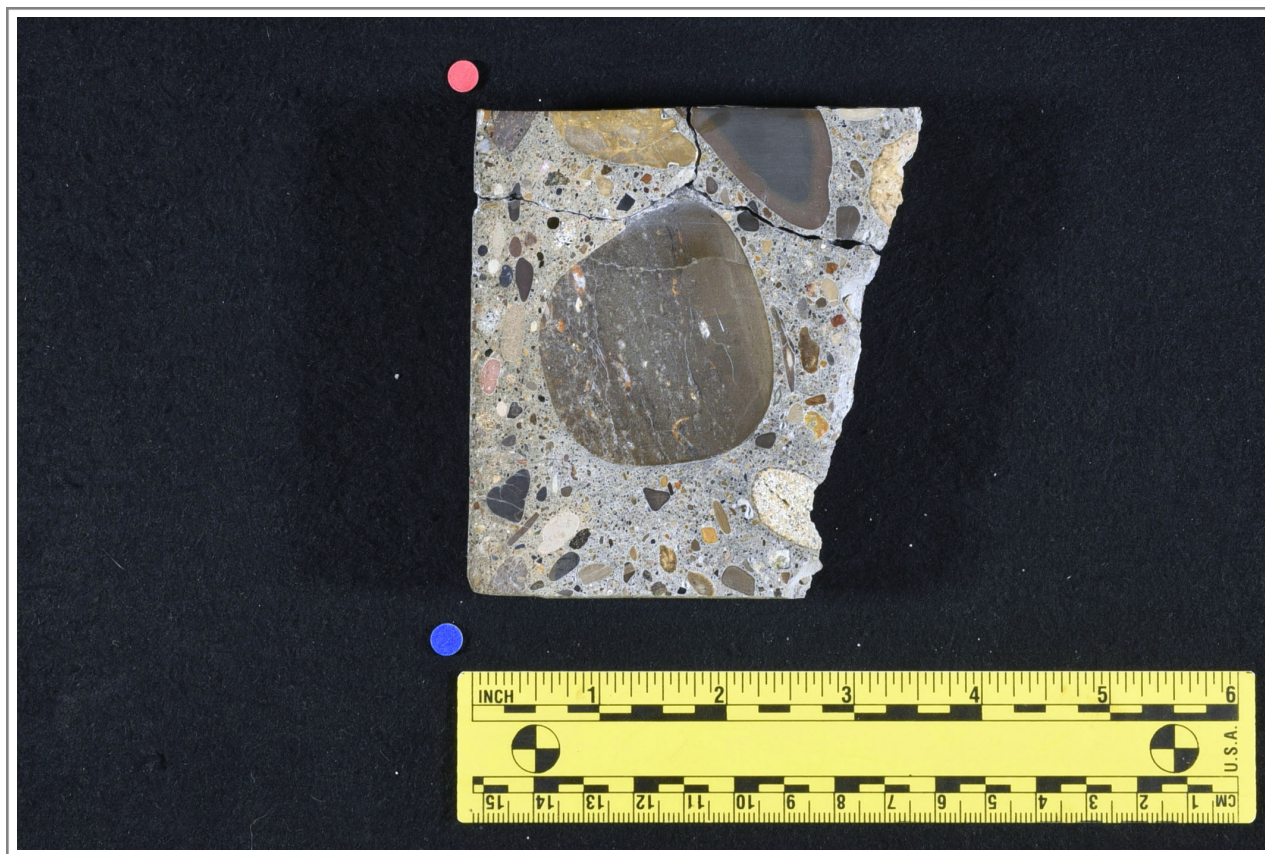
Figure A2. Photographs of the polished surface. The small and large divisions are in centimeters and inches, respectively.

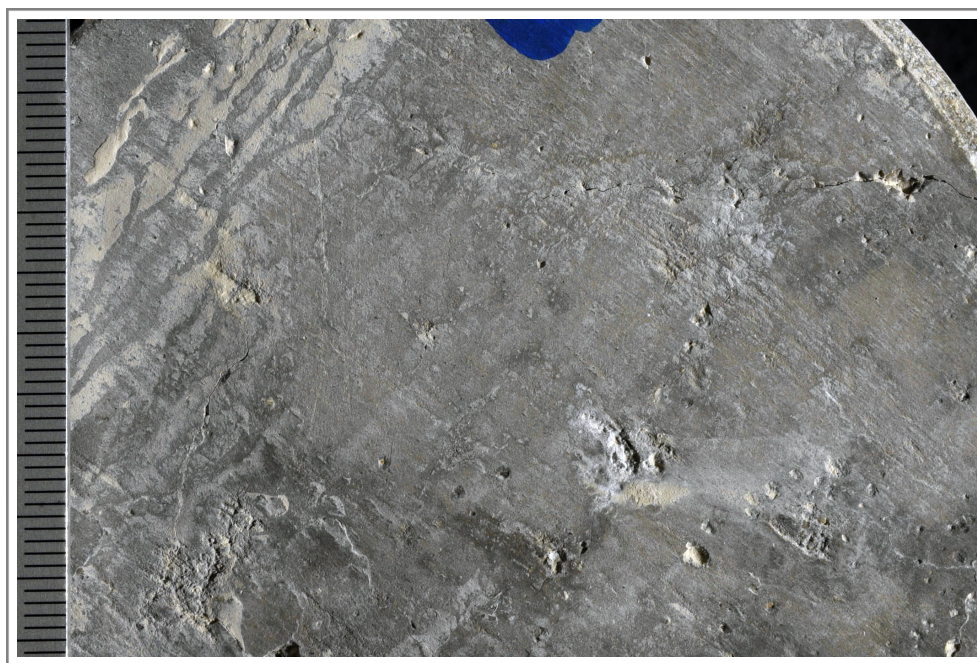
Figure A3. Photograph showing detail of the formed outer surface; scale in millimeters.

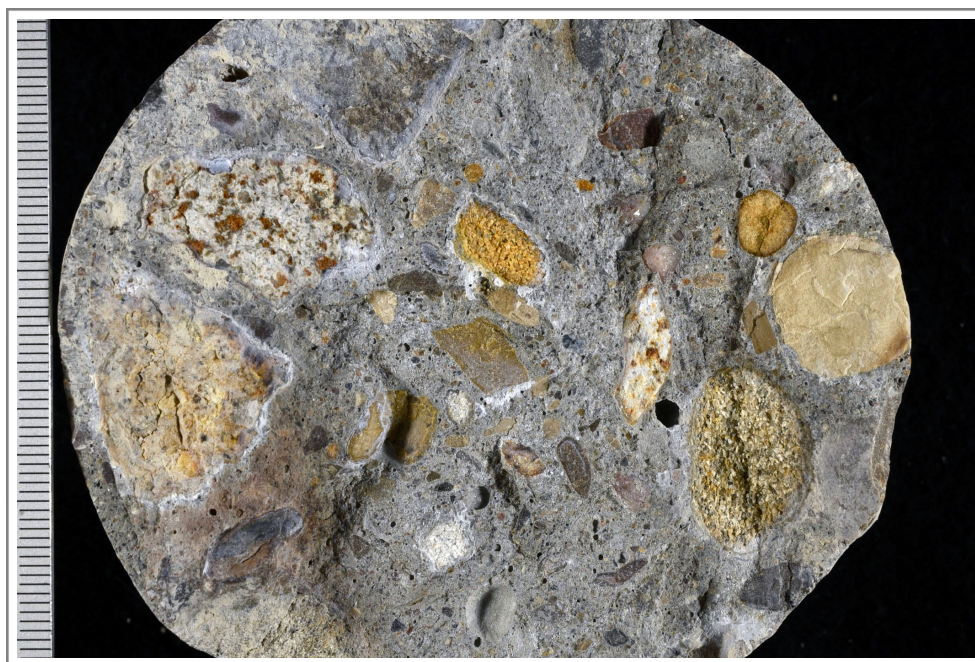
Figure A4. Photograph showing detail of inner fracture surface; scale in millimeters. Note the white deposits of ASR gel on the surface.

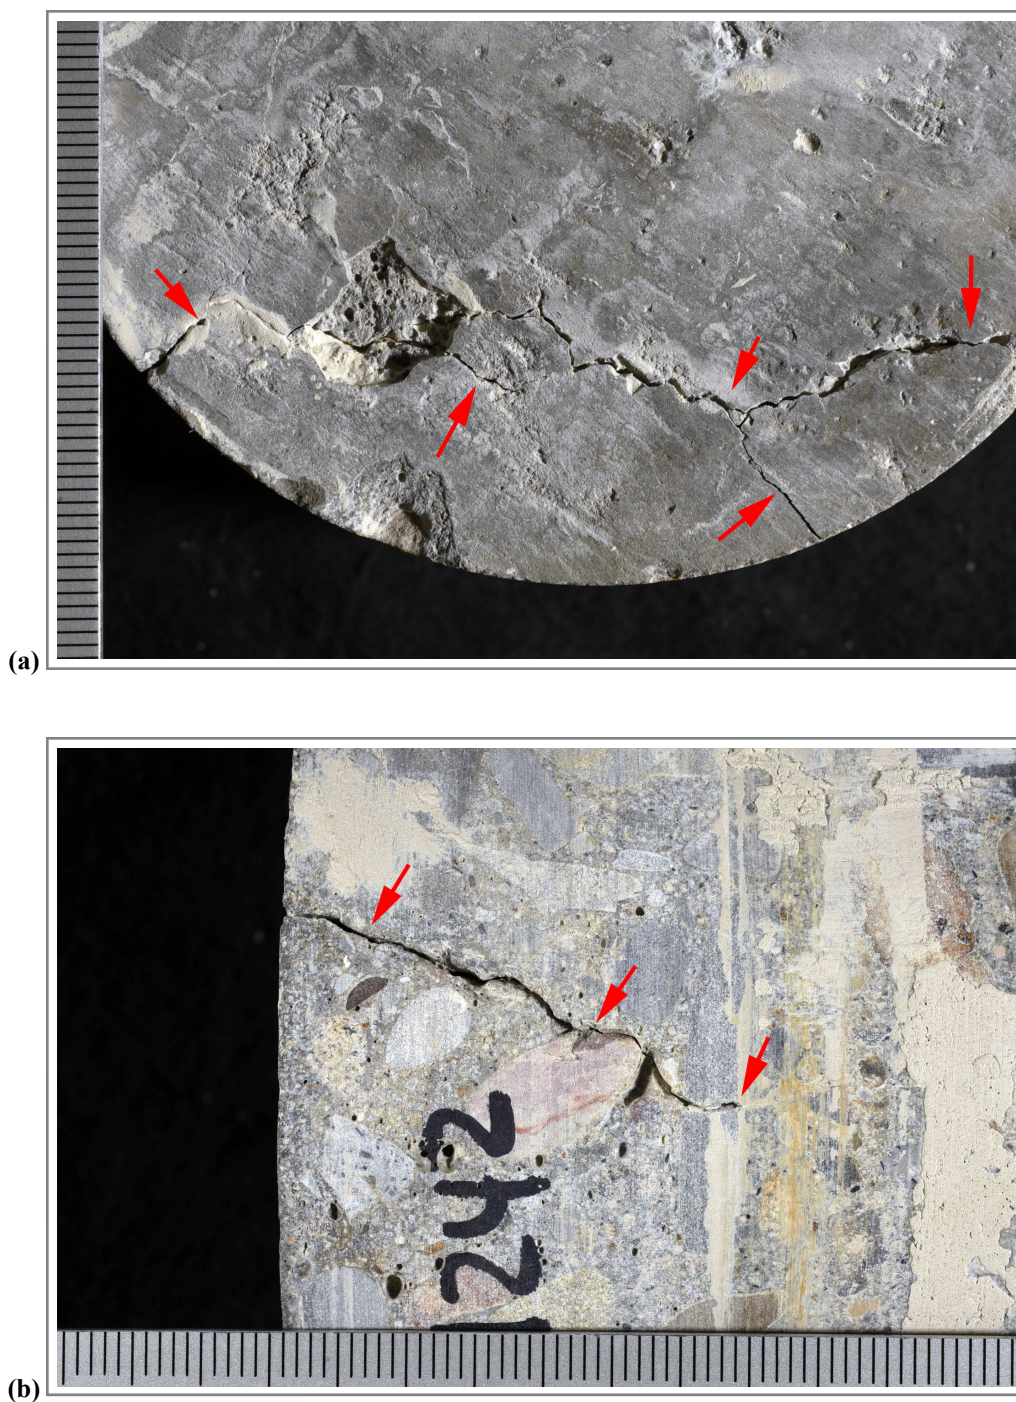
Figure A5. Photographs of the (a) outer surface and (b) side of the core near the outer surface showing overview of major cracks (red arrows). The scale is in millimeters in both photos.

- No steel reinforcement or other embedded objects were observed.
- Linear cracks up to 250 µm (10 mil) were observed on the outer surface that cut sub-horizontally up to 30 mm (1 ⅛ in.) into the core (**Figure A5**). Deposits of gel were observed along segments of the cracks (**Figure A6**). Microcracks ranging from 25-75 µm (1-3 mil) wide were observed over the full depth of the core. The microcracks typically radiate from reactive aggregate particles and contain deposits of ASR gel (**Figure A7**).

3. CRACKING	
MACROSCOPIC	Linear cracks ranging from hairline to 250 µm (10 mil) wide observed on outer surface (Figure A5). Cracks cut mostly sub-horizontally up to 30 mm (1 1/8 in.) on the side of the core. On the polished slab cracks up to 250 µm (10 mil) wide cut through the full length of the core. The cracks cut mostly around but occasionally through aggregate particles. The cracks occasionally show bifurcations into smaller hairline cracks and microcracks. Deposits of ASR gel were observed along the walls of the cracks in distinct segments of their strike length (Figure A6).
MICROSCOPIC	Microcracks observed occasionally over the full depth of the core; the microcracks are mostly 25-75 µm (1-3 mil) wide and up to 6 mm (1/4 in.) long (Figure A7). These microcracks radiate from aggregate particles and contain deposits of ASR gel.

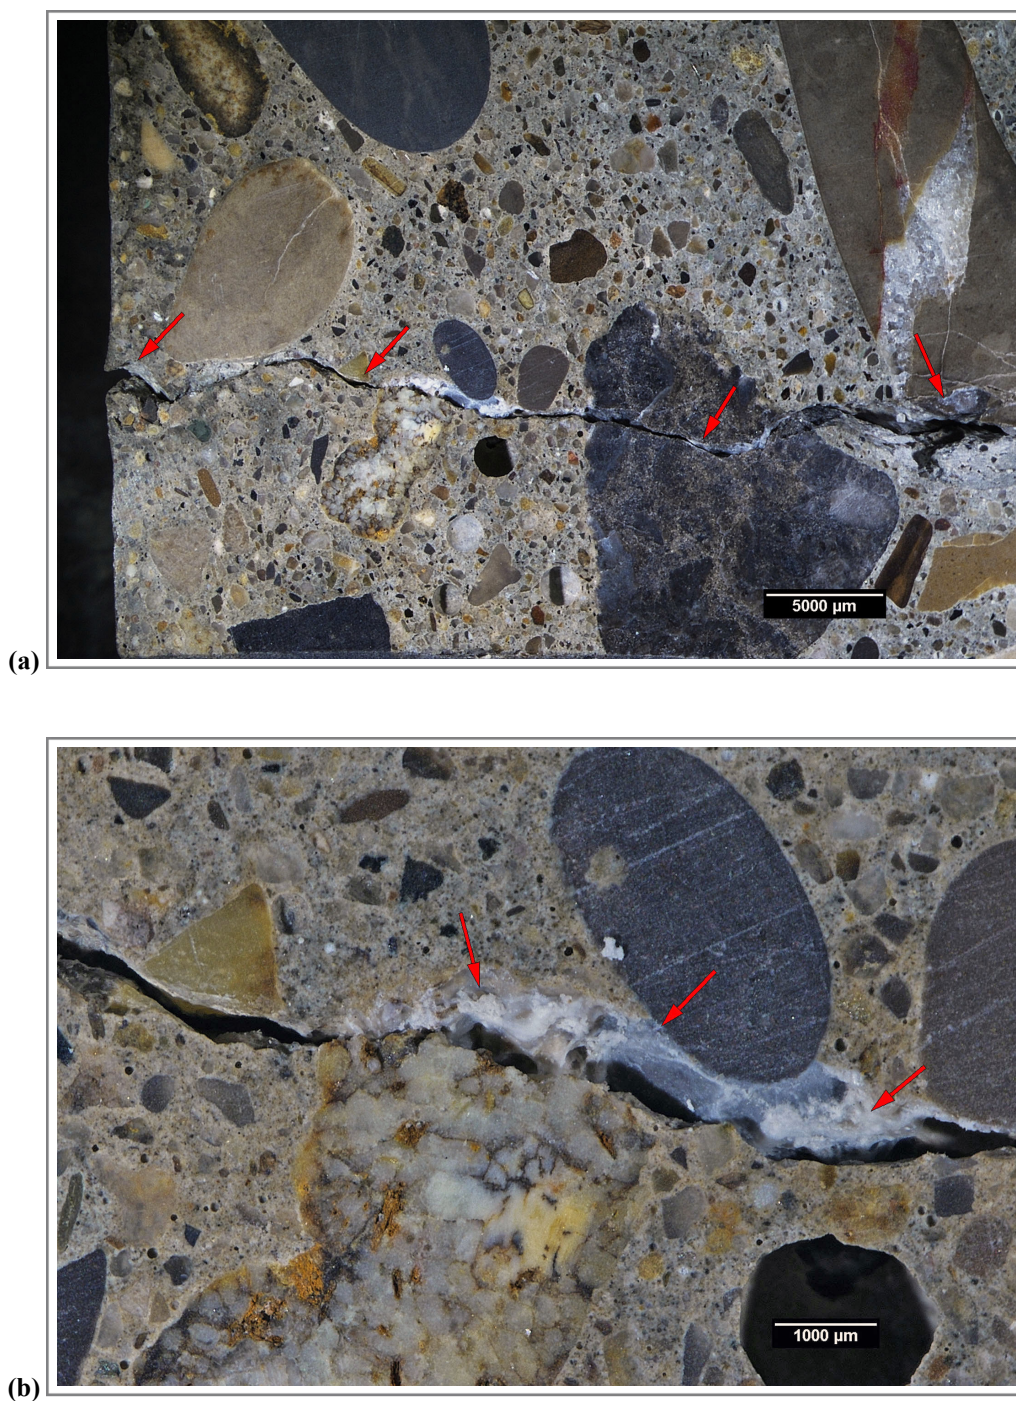
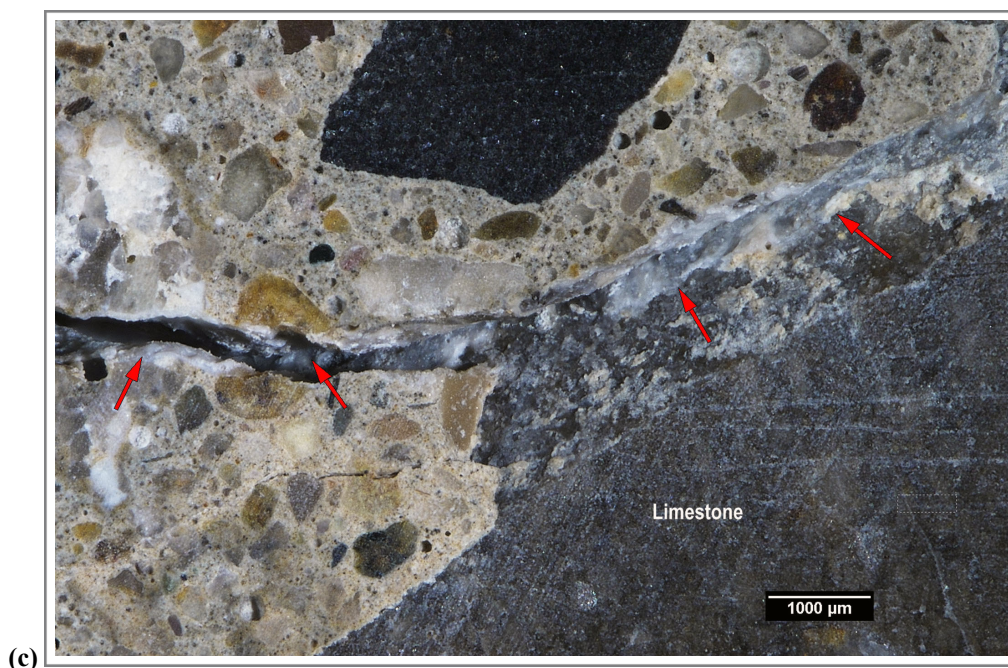
Figure A6. Reflected light photomicrographs of the polished surface showing (a) overview and (b) detail of main crack (red arrows). The area shown in (b) is ~ 20 mm ($\frac{3}{4}$ in.) from the outer surface. The red arrows in (b) highlight deposits of ASR gel that line the walls of the crack.

Figure A6 (cont'd). (c) Reflected light photomicrographs of the polished surface showing detail of main crack about 35 mm (1 $\frac{3}{8}$ in.) from the outer surface. The red arrows show deposits of gel lining a particle of limestone along the crack.

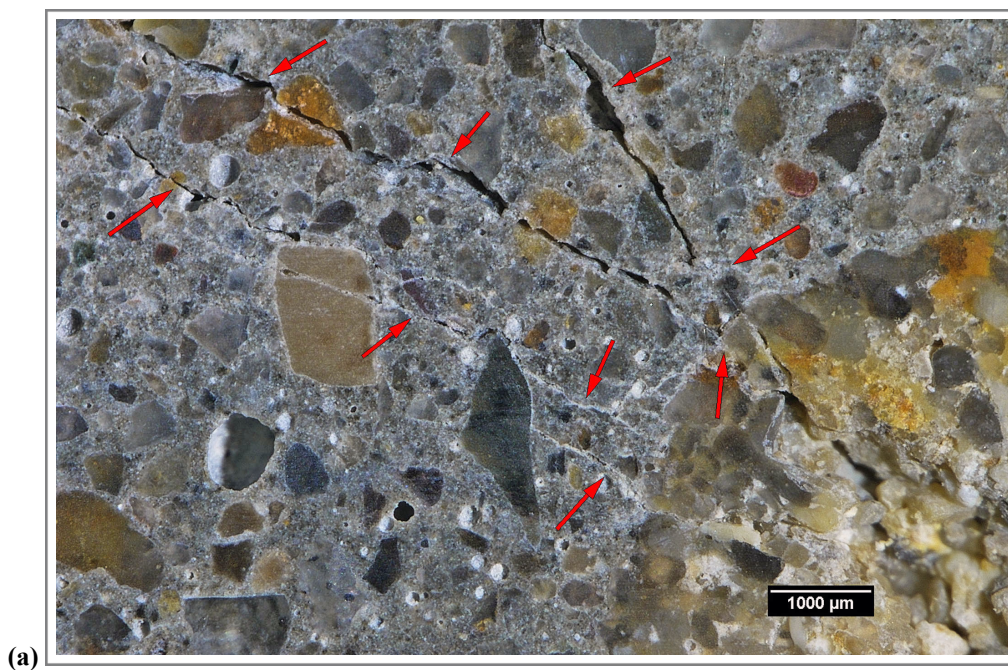
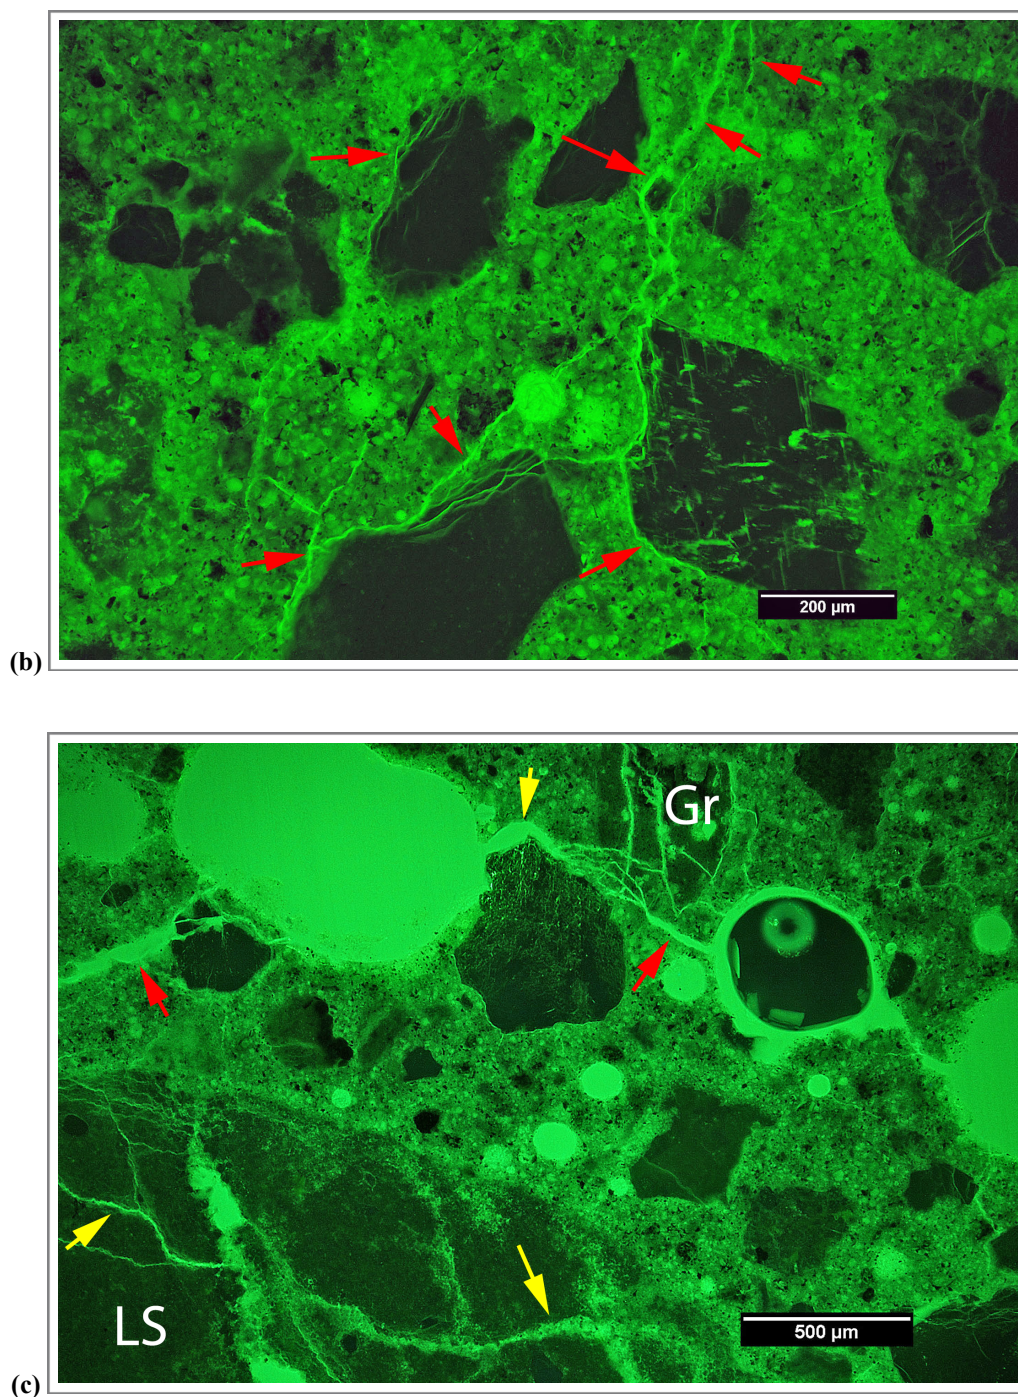
Figure A7. (a) Reflected light photomicrograph of the polished surface showing detail of microcracks (red arrows) cutting from a quartzite particle into the paste ~ 50 mm (2 in.) from the other surface.

Figure A7 (cont'd). Transmitted fluorescent light photomicrographs of thin section showing detail of microcracks associated with ASR. In (a) and (b) the red arrows show microcracks cutting through the paste. In (b) the yellow arrows indicate microcracks within a limestone (LS) particle. Gr indicates a granite particle with numerous internal microcracks.

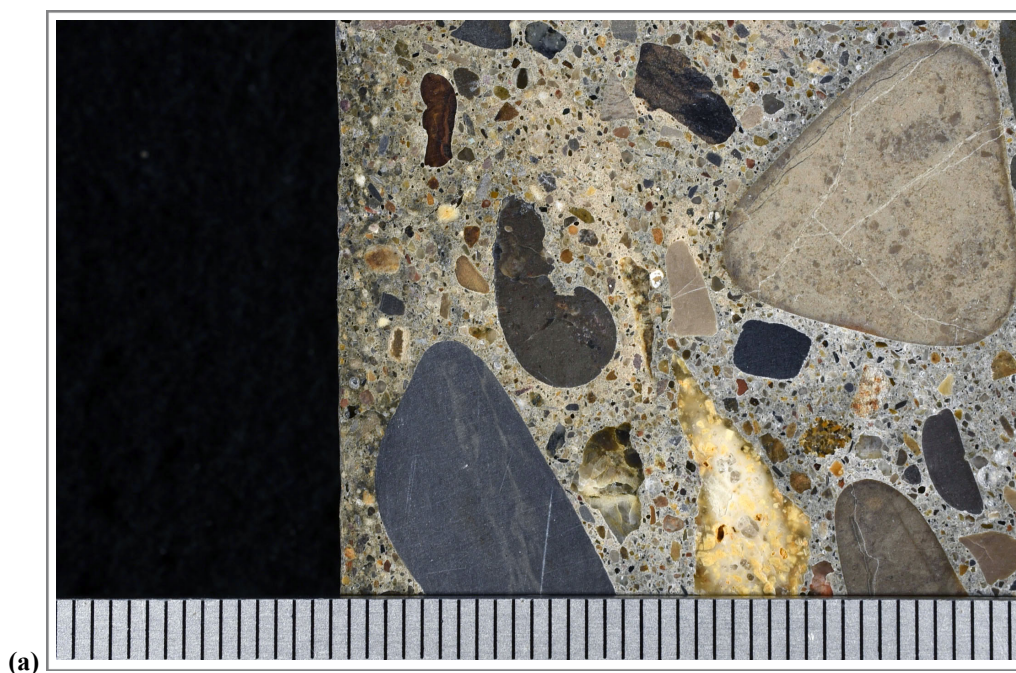
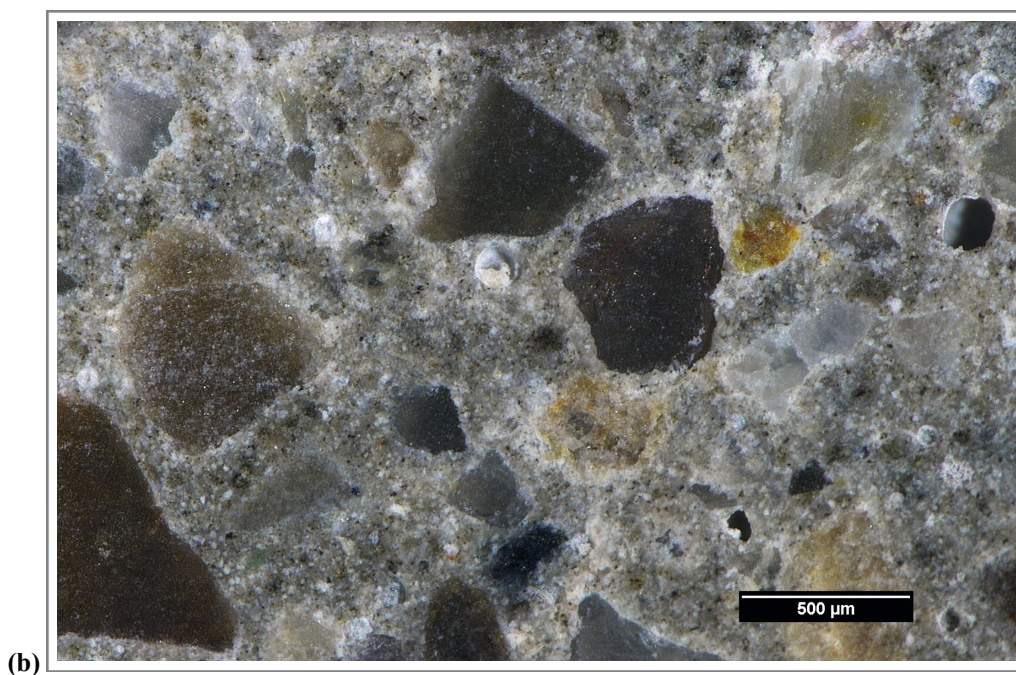
Figure A8. (a) Photograph of the polished surface showing overview of paste at the outer end of the core; scale in millimeters. (b) Reflected light photomicrograph of the polished surface showing detail of paste in the middle of the core.

- The paste is gray in and moderately hard (Mohs ~ 3.0) with a smooth texture and sub-vitreous luster (**Figure A8**). A fresh fracture surface cuts mostly through aggregate particles and shows deposits of ASR gel (**Figure A9**). The paste contains portland cement with no fly ash, slag cement or other supplemental cementitious materials observed; the hydration is normal (**Figure A10**). The capillary porosity of the paste is moderate and the estimated w/c is 0.45 ± 0.05 (**Figure A11**).

4. PASTE OBSERVATIONS	
POLISHED SURFACE	The paste is gray (Munsell 2.5Y/5/1) except in the outer 1-2 mm (40-80 mil) where the paste is dark gray (2.5Y/4/1) and from 15-19 mm (5/8-¾ in.) where the paste is light brown (2.5Y/7/3; Figure A8). The paste is moderately hard (Mohs ~ 3.5) and has a smooth texture and sub-vitreous luster.
FRACTURE SURFACE	Fresh fracture is gray and has a semi-hackle texture (Figure A9). The fracture cuts through > 75% of coarse aggregate particles. Deposits of ASR gel and ettringite were observed.
THIN SECTION	The paste contains hydrated portland cement; no fly ash, slag cement or other SCM were observed. The hydration of the paste is normal to advanced. The hydrated paste contains 4-8% RRCG that consist primarily of belite grains with interstitial aluminoferrite; alite was rarely observed and is very fine-grained with hydration rims (Figure A10). CH is medium-grained and evenly distributed and makes up 8-15% of the paste.

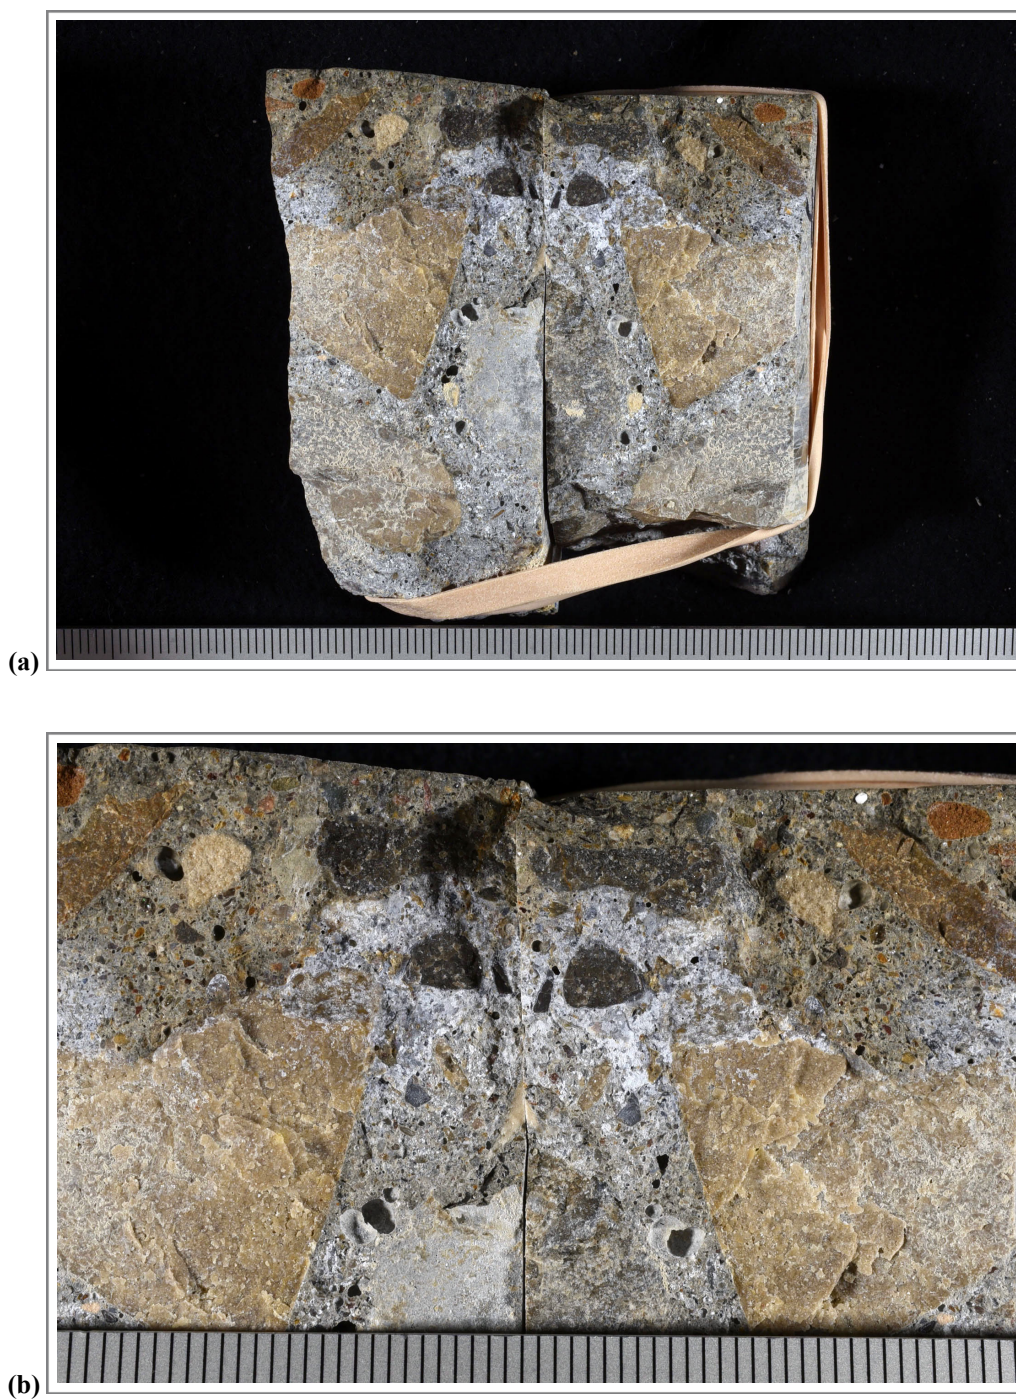
Figure A9. Photographs showing (a) overview and (b) detail of fresh fracture surface. The scale is in millimeters in both photos.

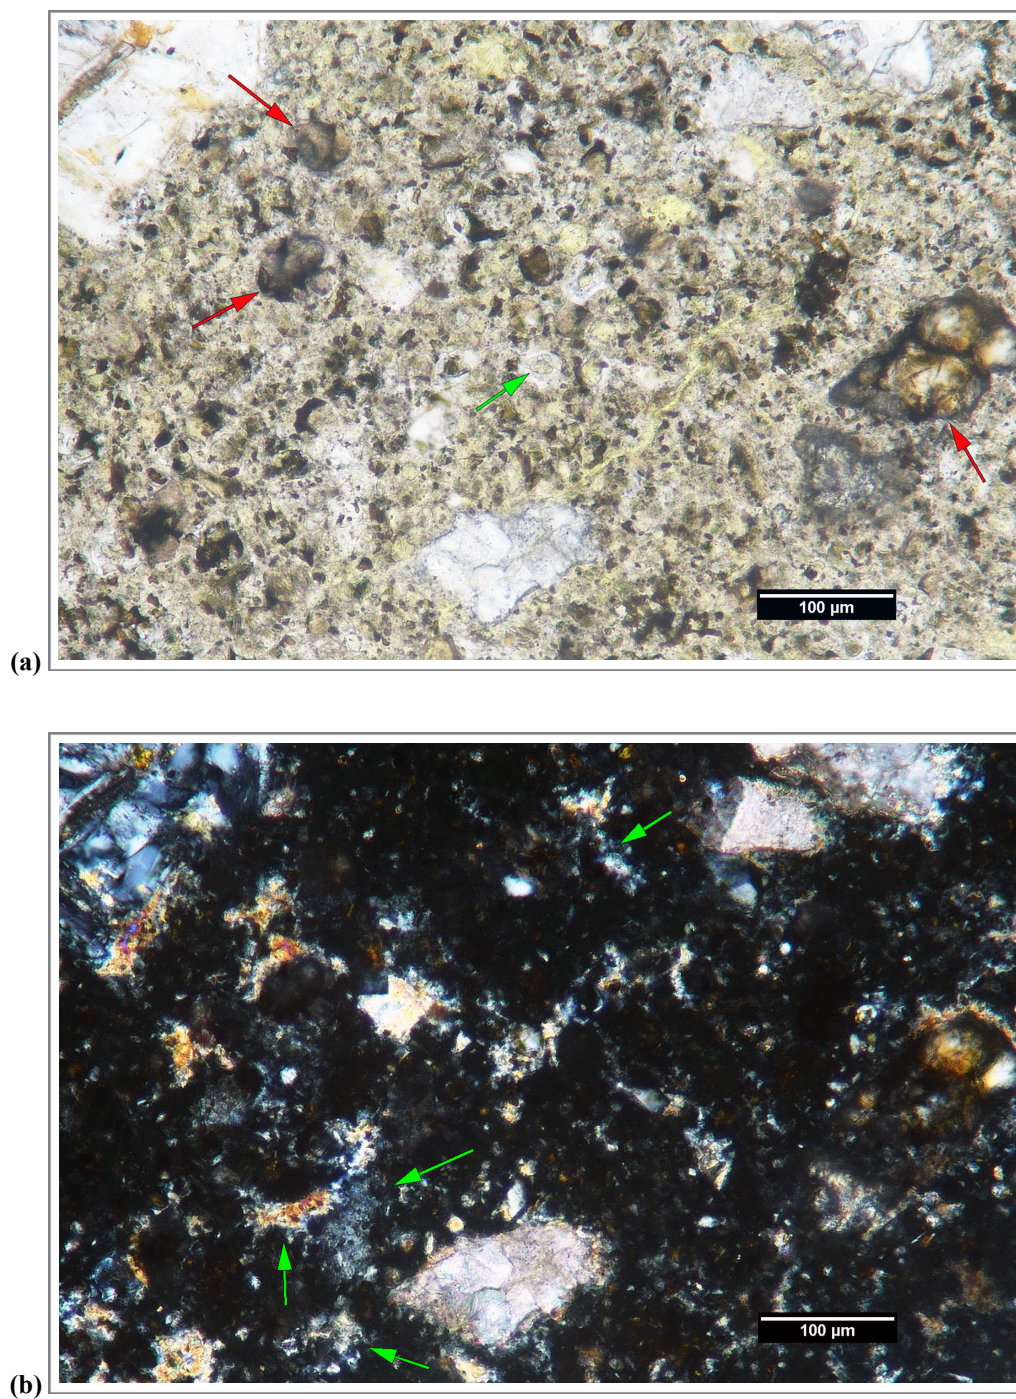
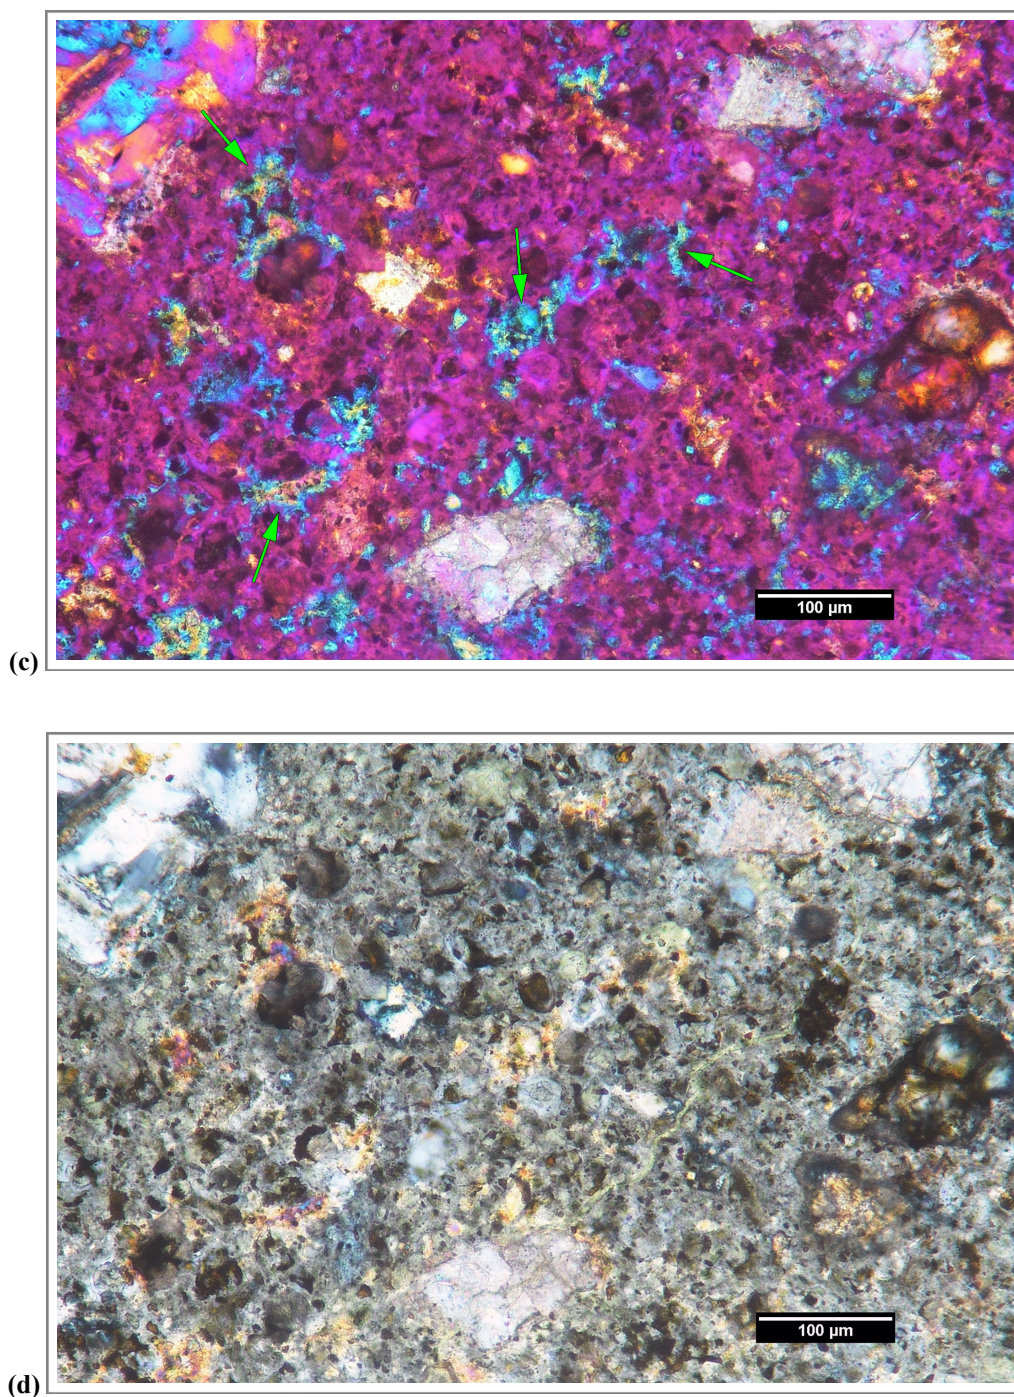
Figure A10. Transmitted light photomicrographs of thin section showing detail of paste in (a) plane-polarized and (b) cross-polarized light. The red and green arrows in (a) indicate grains of belite and alite, respectively. In (b) the green arrows indicate calcium hydroxide.

Figure A10 (cont'd). Transmitted light photomicrographs of thin section showing detail of normally hydrated paste in the middle of the thin section in (c) cross-polarized light with the gypsum plate inserted and (d) cross-polarized light with the quarter wavelength plate inserted. In (c) the green arrows indicate calcium hydroxide.

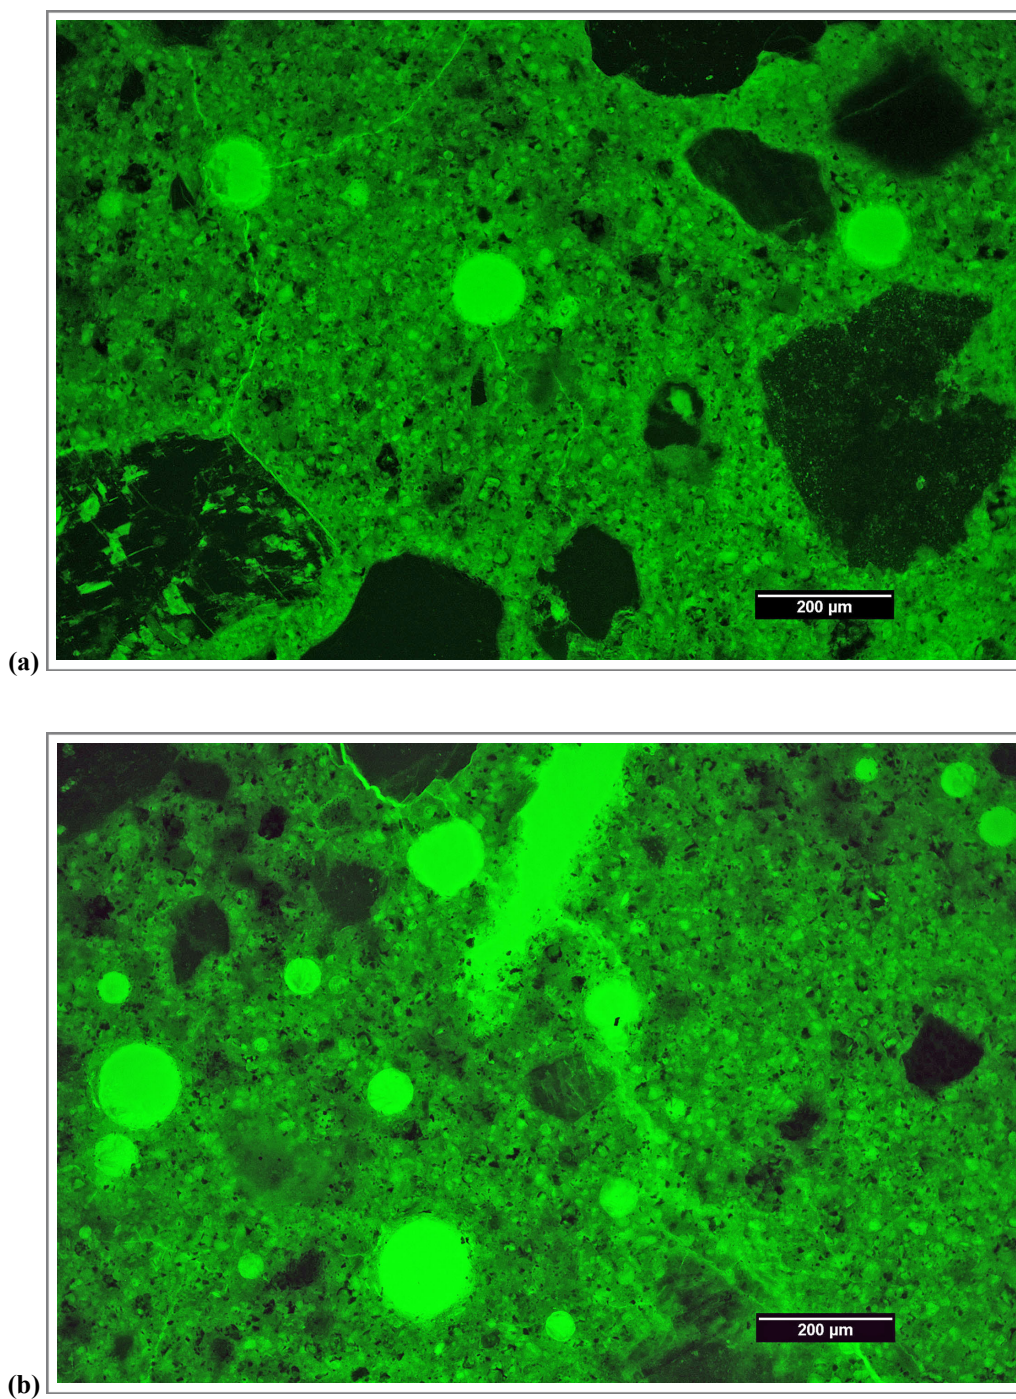
Figure A11. Transmitted fluorescent light photomicrographs of thin section showing detail of paste in the middle of the thin section. The black areas correspond to aggregate that has very low or effectively zero percent porosity and the bright green circles are air voids filled with epoxy that have 100% porosity. The variations in green between these end members reflect variations in the capillary porosity or micro-density of the paste.

ESTIMATED W/CM	The capillary porosity of the majority of the paste is moderate and moderately heterogeneous (Figure A11). The estimated w/cm is 0.45±0.05.

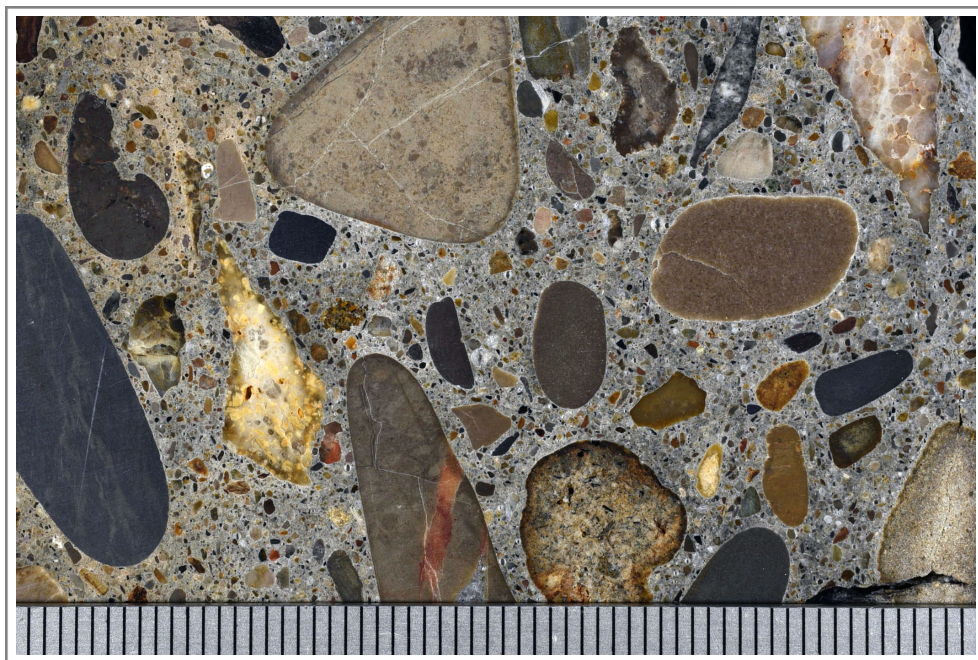
Figure A12. Photograph of the polished surface showing overview of the coarse aggregate in the core; scale in millimeters.

- The coarse aggregate is a natural gravel that has a 50 mm (2 in.) nominal top size but most particles are 19 mm (¾ in.) or less (**Figure A12**). The aggregate is a mixture of carbonate and siliceous rocks that include limestone, quartzite, granitic rocks, chert and siliceous volcanic rocks. Some of the limestones are siliceous. The fine aggregate is a natural sand that consists of rock types similar to those observed in the coarse aggregate (**Figure A13**). Evidence of ASR was observed involving siliceous limestone, granitic rocks and quartzites (which contain class of chert) in the coarse and fine aggregate.

PHYSICAL PROPERTIES	The coarse aggregate is a natural gravel with a 50 mm (2 in.) nominal top size but most particles are 19 mm (¾ in.) or less across (Figure A12). The rocks are hard and compact. The particles are sub-equant to slightly elongated in shape with well-rounded to sub-rounded edges. The limited length of the core precludes discussion of grading and distribution.
ROCK TYPES	The coarse aggregate is a mixture of carbonate and siliceous rocks that are mostly sedimentary and igneous in origin. Major rock types include limestone, quartzite, granitic rocks and siliceous volcanic rocks such as rhyolite. The limestones range from massive micritic rocks to sandy limestones. None of the limestone shows evidence of significant dolomitization and none of them contain argillaceous seams or have textures commonly associated with rocks that are potentially susceptible to alkali-carbonate reaction (ACR). Quartzite, granitic rocks and siliceous volcanic rocks are potentially susceptible to alkali-silica reaction (ASR).

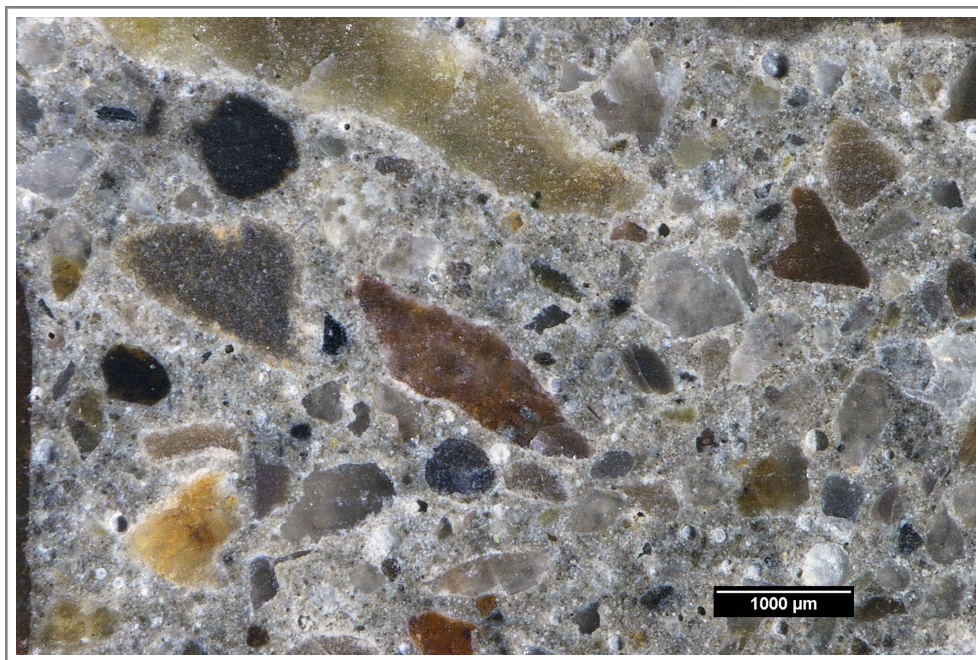
Figure A13. Reflected light photomicrograph of the polished surface showing fine aggregate in the core.

PHYSICAL PROPERTIES	The fine aggregate is a natural sand that consists of particles that are hard and compact. The particles are mostly sub-equant in shape with sub-angular to sub-rounded edges. The grading and distribution is relatively even (Figure A13).
ROCK TYPES	The fine consists of a mixture of rock types similar to those observed in the coarse aggregate.
OTHER FEATURES	Evidence of ASR involving granitic rocks and quartzite in the sand was observed. No deleterious coatings or encrustations were observed. No low w/c mortar coatings were observed. No evidence of ACR observed.
